MODIFICATION.REAR BRAKE EQUALISER.

MODEL BENTLEY MARK VI

ALTERATION TO BRAKE LINKAGE ADJUSTMENT

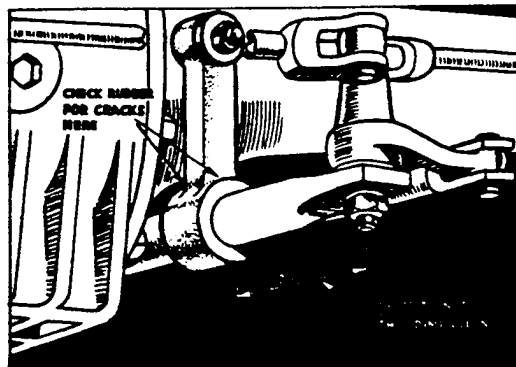
A certain number of cars were built with the rubber support of the rear brake equaliser fitted and positioned whilst in the chassis stage of production. When the body is mounted, the effect of its weight on the geometry of the rear suspension causes distortion of the support which may lead to fracture; repositioning of the support is therefore necessary in some cases.

The attached drawing and following procedure give the necessary information required for carrying out the examination and repositioning of the rubber support.

1. Disconnect the rubber support from the axle tube and flex it backwards and forwards so as to examine for cracks in the neck at the junction with the main boss. If there are any signs of cracks, replace with a new support.
2. Check that the rear face of the main boss is 2.275 ins. from the centre of the rear brake equaliser bolt, and reposition if necessary.
3. Paint the letter 'E' on the rear face halfway down the rubber leg after examination and repositioning.

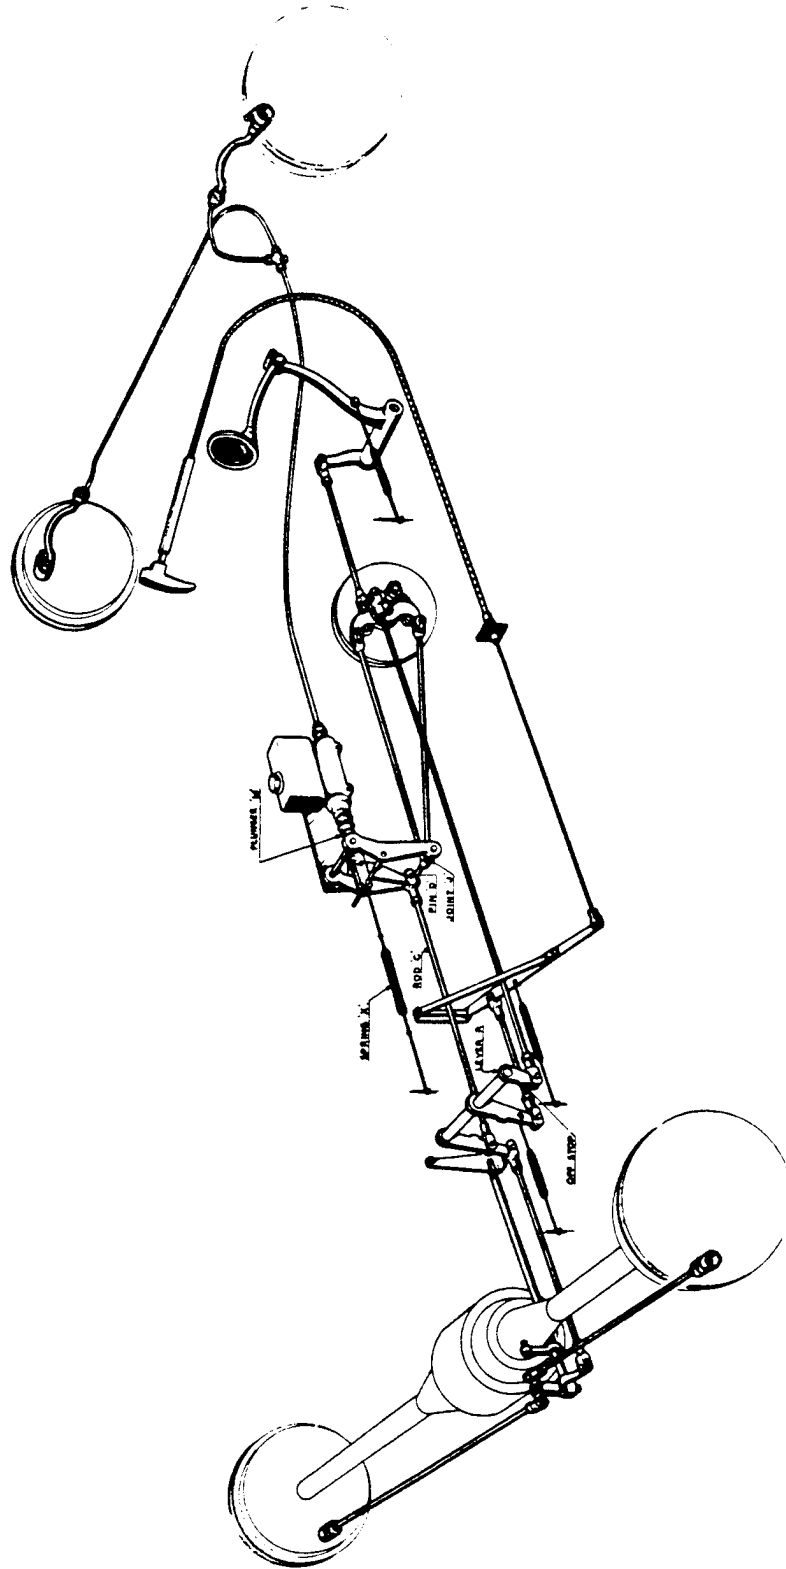
A modification is introduced to reduce a mechanical noise that can more accurately be described as a "clonk" from the brake linkage which may occur on application of the brakes.

In many cases, the origin of this noise has been traced to excessive free travel between the plunger and piston of the brake master cylinder, and adjustment of the brake linkage as described hereunder, has in certain instances effected a noticeable reduction of the noise.

The attached drawing shows the linkage involved in carrying out this adjustment:-

1. Ensure that the rear brakes are in the OFF position and that the lever 'R' is against its OFF stop.
2. Remove the master cylinder pull-off spring 'X' and the clevis pin 'D'
3. Adjust the rod 'C' so that the joint 'J' has zero to .050" free travel before the plunger 'M' contacts the master cylinder piston.
4. Tighten the locknut on the rod 'C'. Replace the clevis pin 'D' and the master cylinder pull-off spring 'X'.
