MODEL BENTLEY MARK VI

MODIFICATION.HORN PUSH BUTTON ASSEMBLY.

MODIFICATION.CATEGORY: 3A.WINDSCREEN WIPERS - ELIMINATION OF NOISE.

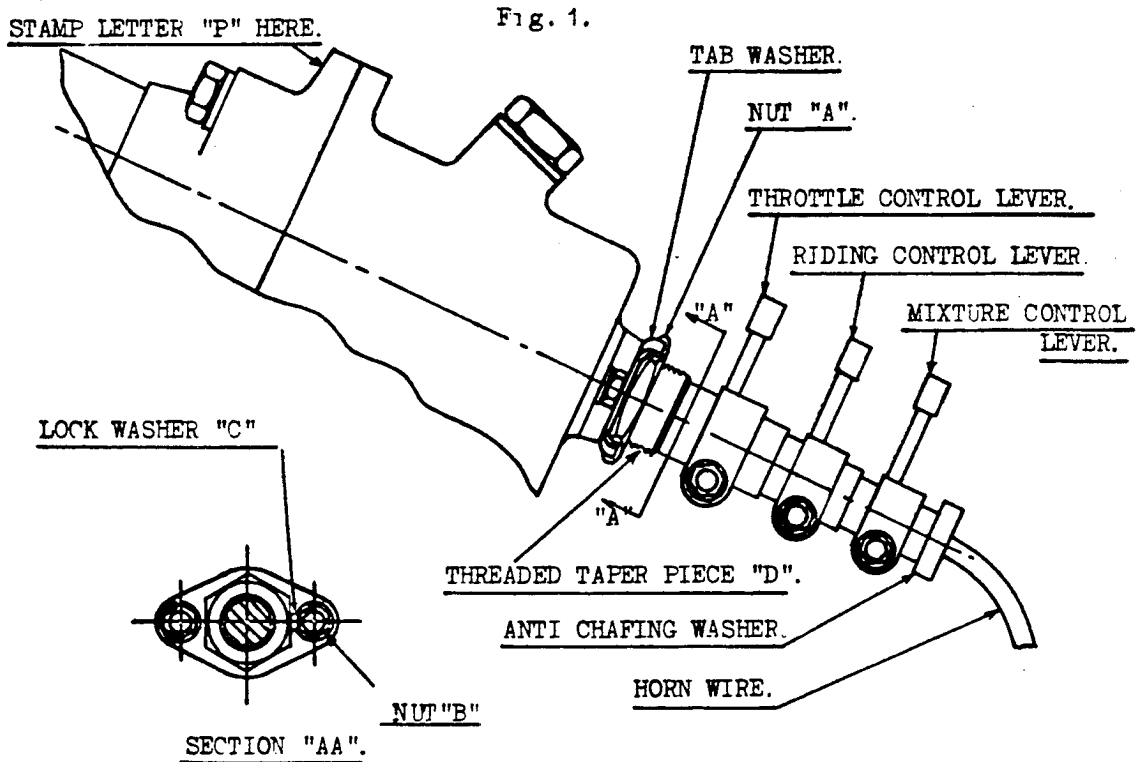
A modification is introduced to the horn push button assembly to give additional strength where the contact pillar is screwed into the horn push. The alteration consists of the substitution of the taper pin locking by sweating.

Fig.1. Remove clip fastening horn wire to off-side valance plate and anti-chafing bush from tube at bottom of steering box, remove the pinch bolts and slide the throttle, riding and mixture control levers downwards off their tubes.

Loosen tab washer and remove the nut 'A' from the threaded taper piece 'D'.

Remove the near-side nut 'B' and its lockwasher.

Temporarily fit the nut 'A' back onto the threaded taper piece three or four threads and give it a few sharp taps towards the steering box to loosen the threaded taper piece from its seating. after which the nut can be removed and slipped downwards over the tubes. A receptacle should be placed at the bottom of the steering box to catch the oil that will be lost during the next operation.

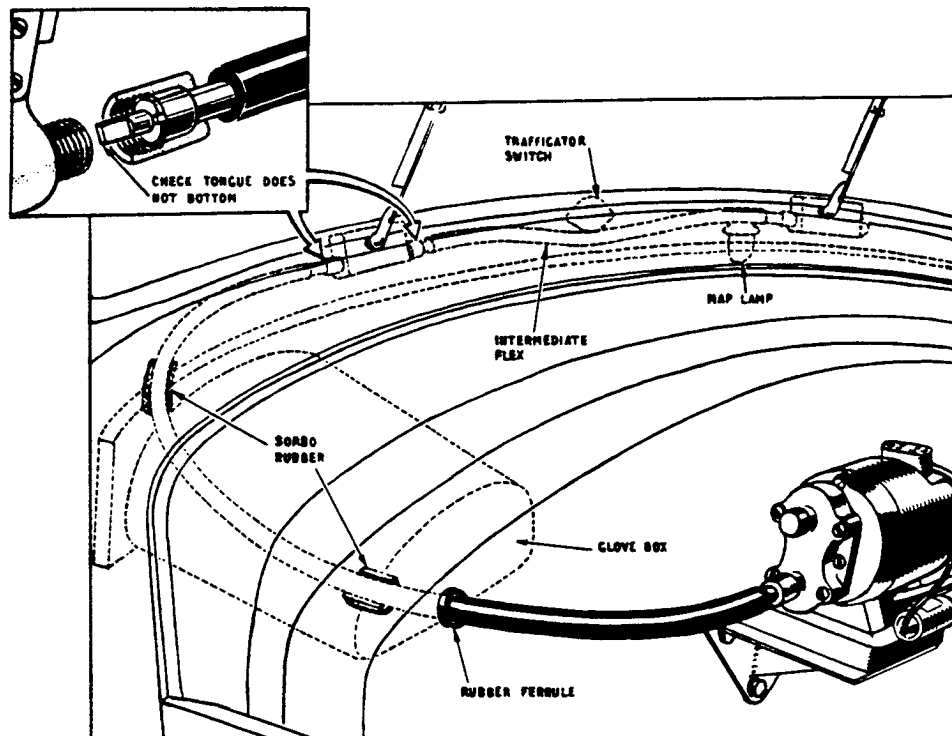
It has been found that noisy operation may be due to any of the following causes:-

- (a) Flexible drives fouling the scuttle rail or glove box.
- (b) Rigid attachment of the gearboxes to the scuttle rail.
- (c) Awkward bend in flexible drive or bottoming of tongues.
- (d) Noisy gearbox.

Having removed the screen finisher, switch on the wipers with the arms removed and listen for noise. Check that the flex does not foul at the points shown in the sketch and if necessary, add small pieces of sorbo rubber to prevent contact.

Slack off the gearbox fixing screws and see whether the noise is appreciably diminished. Rubber sheet in place of the felt mounting pad will be found to effect an improvement. The screws can be left only partially tightened with perfect safety.

If the noise persists, check that the driving tongues do not bottom in the slots; if necessary, shorten them by filing. Also make sure that the intermediate flexible drive is in the best position for lack of noise by slacking off the knurled nuts and twisting the outer flex to a new position.
