Reuse And Salvage Guidelines

Cylinder Liners

Media Number -SEBF8068-01

GUIDELINE FOR REUSABLE PARTS AND SALVAGE OPERATIONS

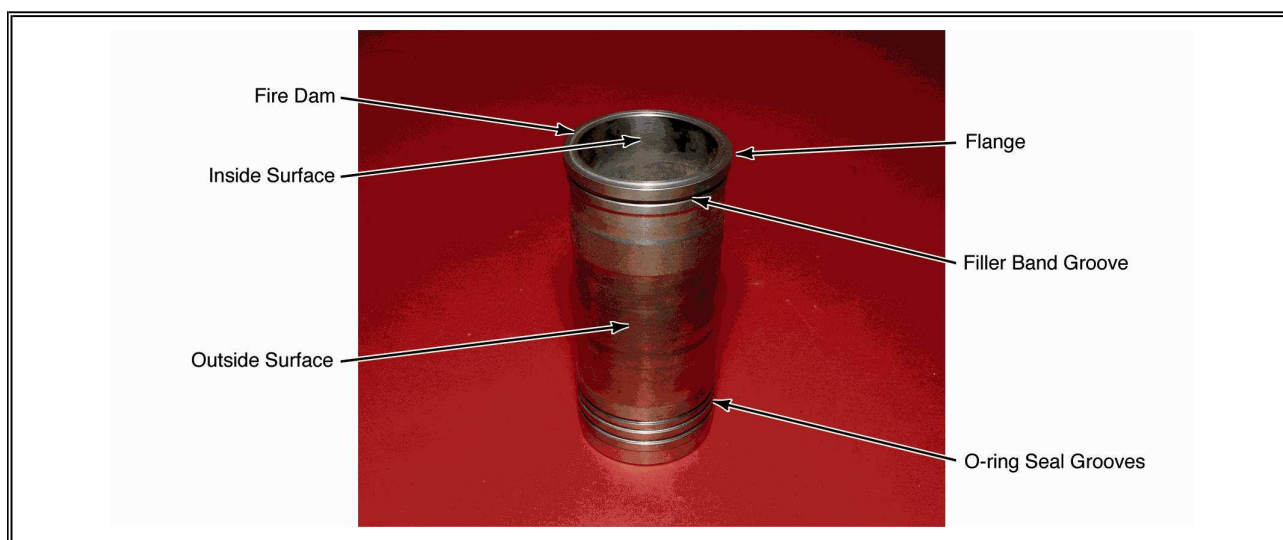
Illustration 1

Typical cylinder liner.

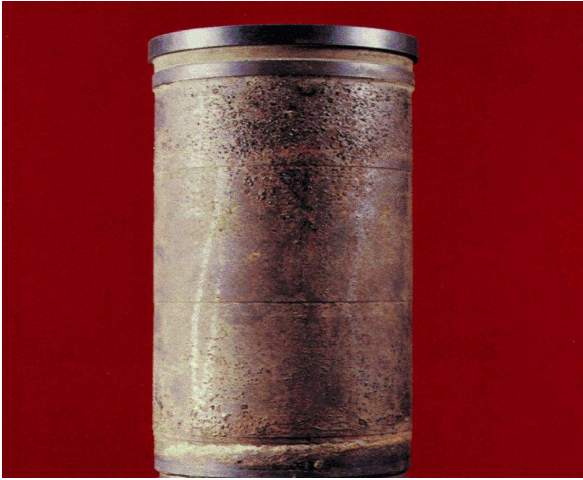
Illustration 2

Rust and deposits, like these, on the outside surface must be removed before the visual inspection.

Before you start the visual inspection, remove any rust and/or deposits from the outside surface of the liner. Use glass beads, a wire brush installed on a pedestal grinder or a similar method

which will not damage the inside diameter or the top or bottom of the flange. See Illustration 2.

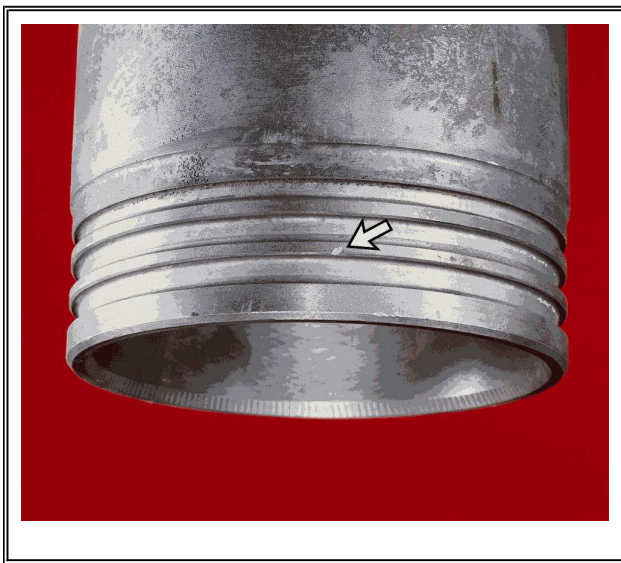
Illustration 3

Small chip in the area between the grooves.

Use again -

if the chip is not extended across the complete area and any burrs or sharp edges are removed with a file.
