Body Repair Manual

This Body Repair Manual provides detailed repair procedures for repair of commonly damaged structural panels on the Hyundai 2006 SANTAFE(CM). To aid in the information of the damaged vehicle, body construction, replacement parts, body dimensions, body sealing locations, corrosion protection, body modification tools, plastic parts and body repair procedures are contained herein.

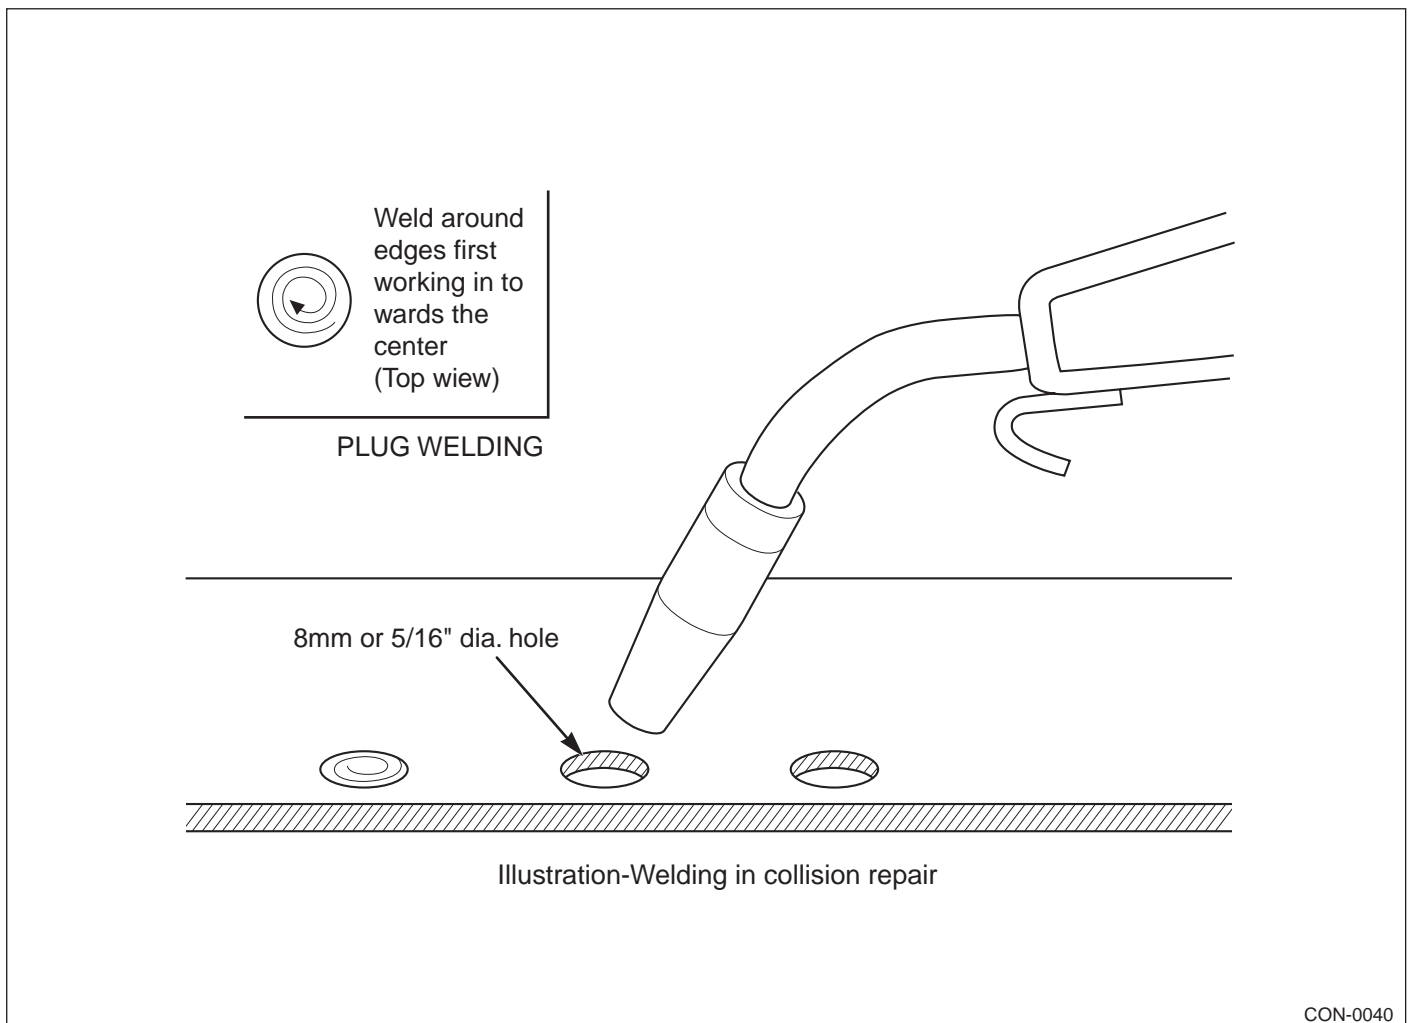
During the repair process, plug welds are used to duplicate original factory spot welds. All plug welds should be done with the MIG welder. An 8 mm (5/16") hole is placed in the top (welding side) sheetmetal.

You then begin welding along the edges and the spiral towards the center (see illustration). This is important so that weld penetration between the two metal pieces takes place along the circumference of the circle.

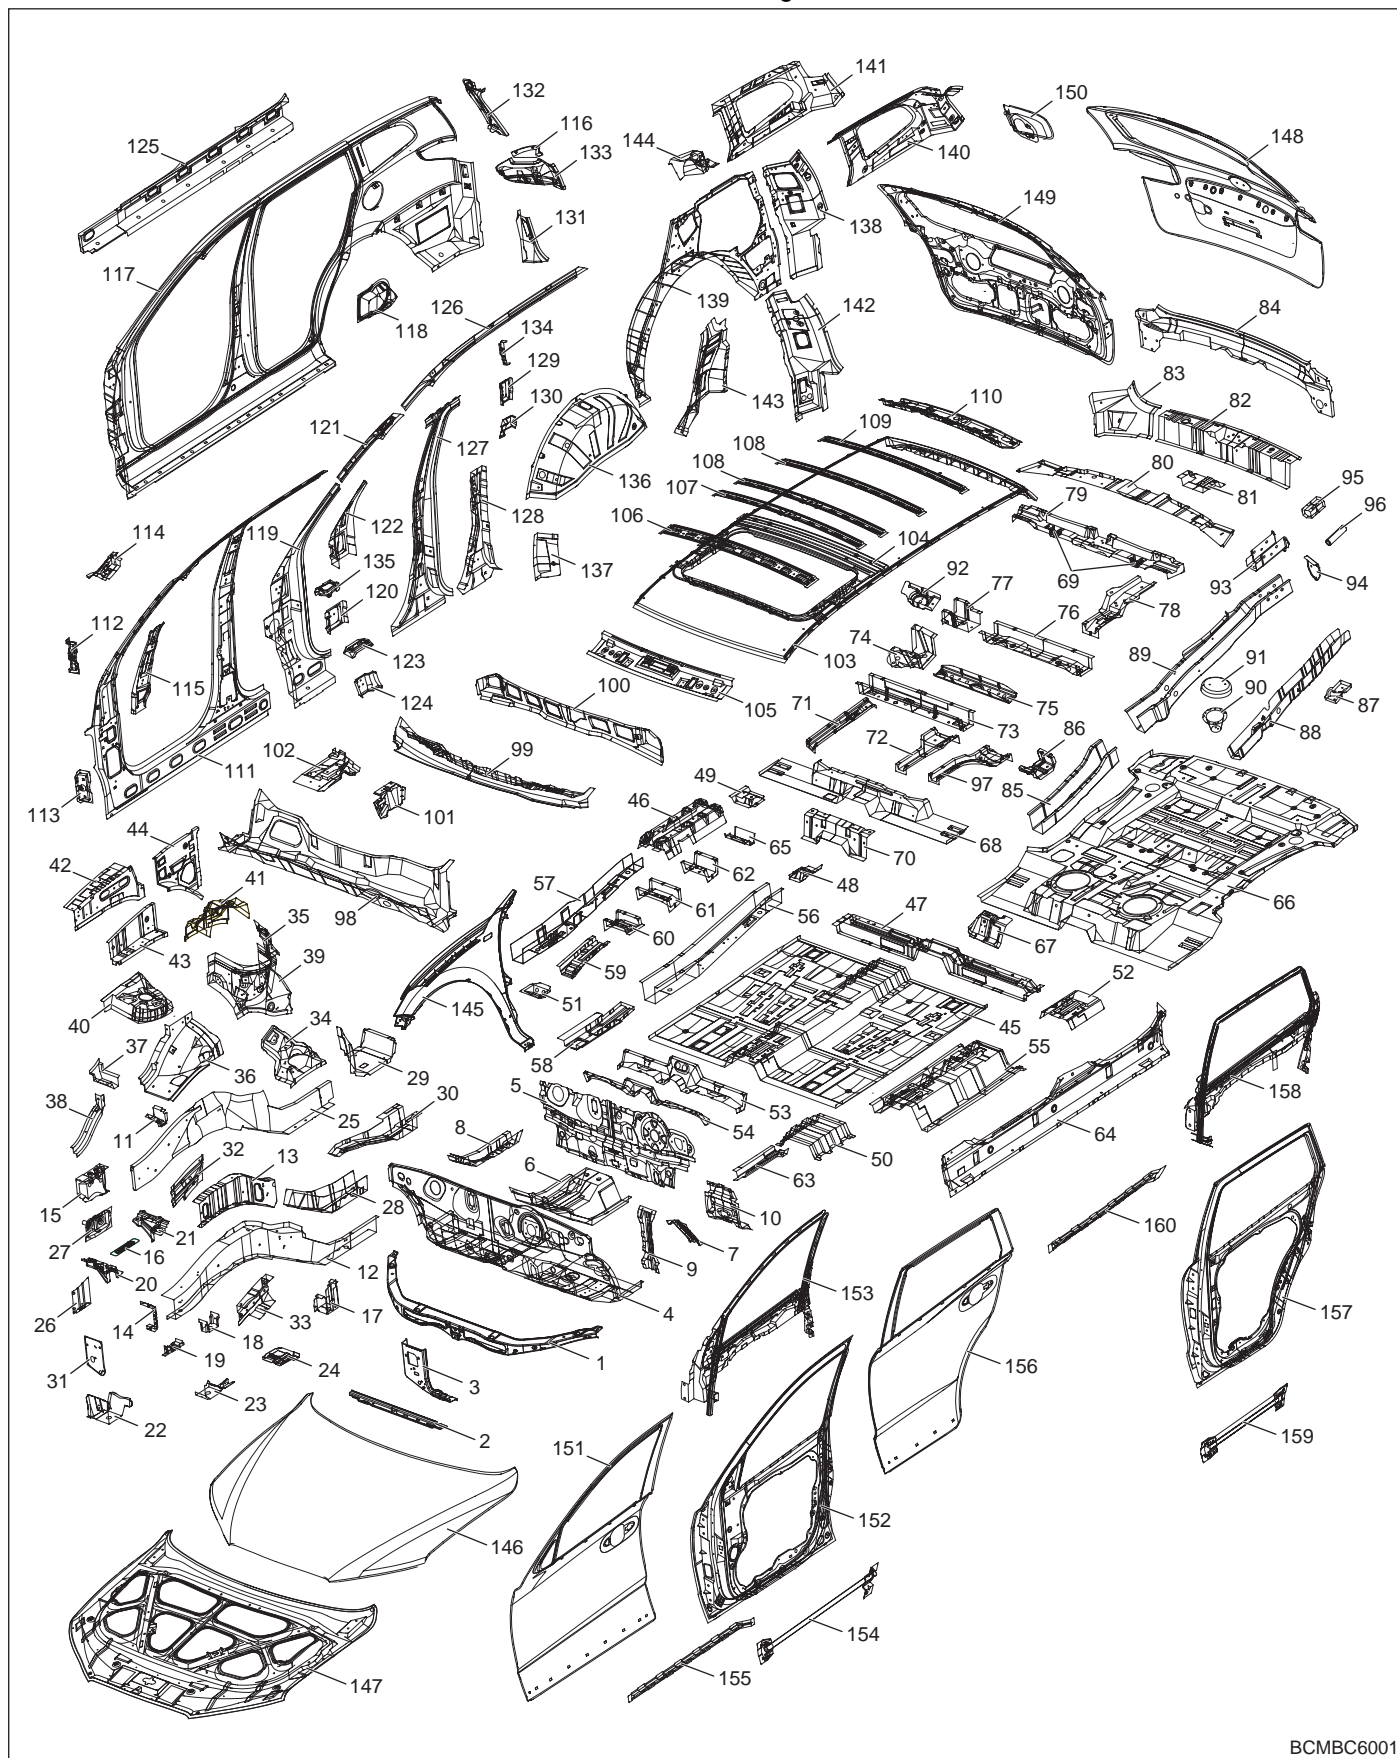
BODY COMPONENTS

Body construction will sometimes differ depending on specifications and country of destination. Therefore, please keep in mind that the information contained herein is based on vehicles for general destination.
